# Home Report

## The Old Croft House Bohuntinville Roy Bridge PH31 4AH

Inspected On: 21<sup>st</sup> March 2018

**Prepared by:**  
Samuel & Partners  
First Surveyors Scotland  
44 High Street  
FORT WILLIAM  
PH33 6AH

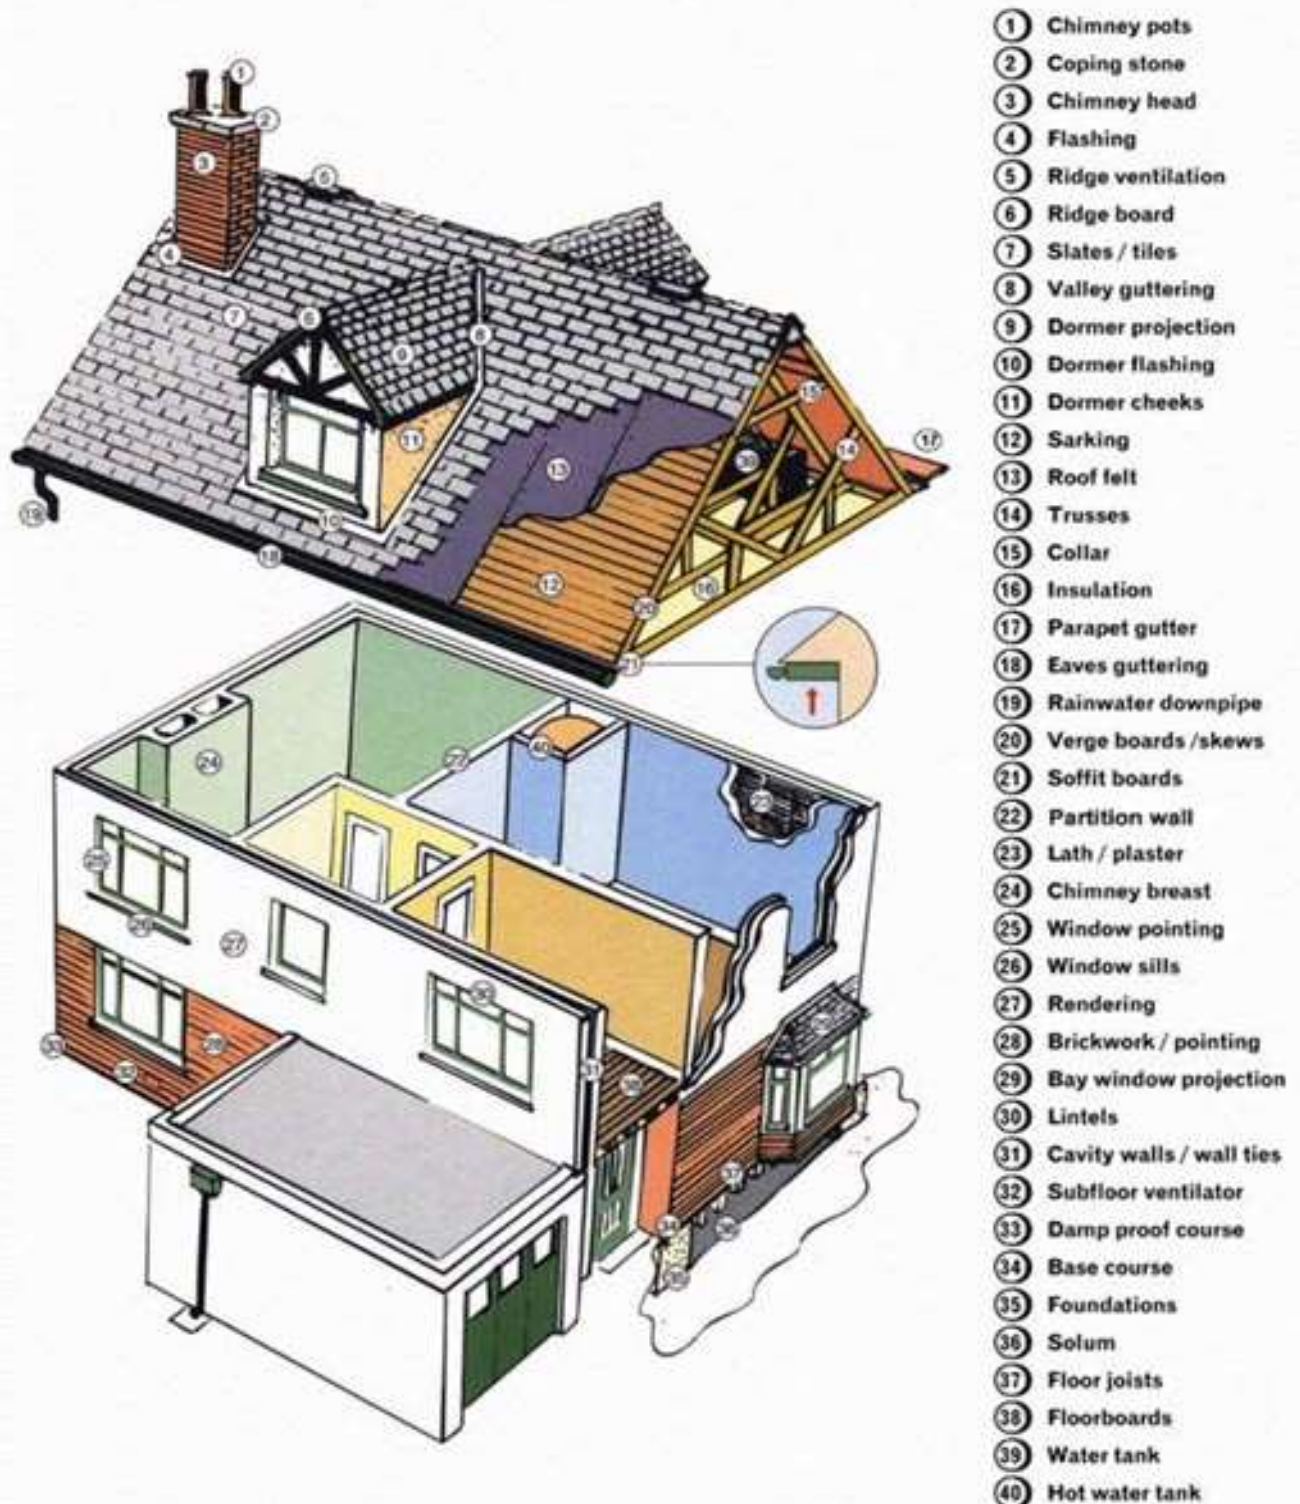
## Sectional Diagram showing elements of a typical house

Reference may be made in this report to some or all of the above component parts of the property. This diagram may assist you in locating and understanding these items.
