# **HOME REPORT**

#### **LUCKEN HOWE EILDON**

**MELROSE TD6 9HB**

# SINGLE SURVEY

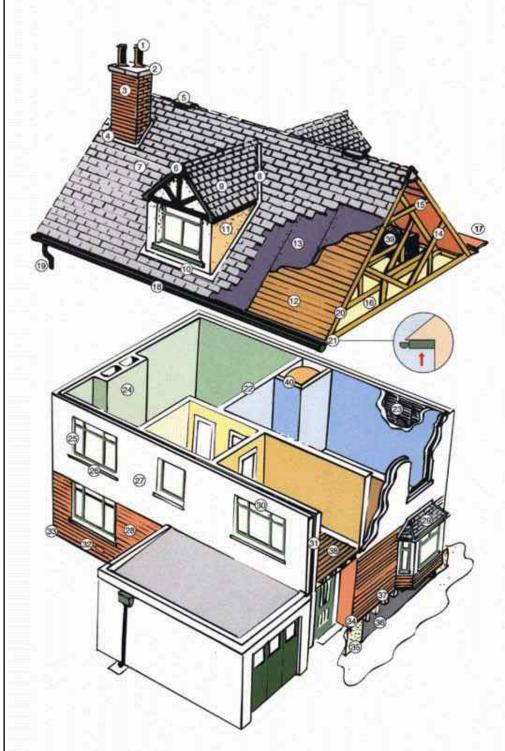
#### Sectional Diagram showing elements of a typical house

Reference may be made in this report to some or all of the above component parts of the property. This diagram may assist you in locating and understanding these items.

- 1 Chimney pots
- 2 Coping stone
- 3) Chimney head
- 4) Flashing
- (5) Ridge ventilation
- 6) Ridge board
- 7) Slates / tiles
- 8 Valley guttering
- 9) Dormer projection
- 10 Dormer flashing
- 11) Dormer cheeks
- (12) Sarking
- (13) Roof felt
- (14) Trusses
- (15) Collar
- (16) Insulation
- 17) Parapet gutter
- 18) Eaves guttering
- 19) Rainwater downpipe
- 0) Verge boards /skews
- 21) Soffit boards
- 22) Partition wall
- 23) Lath / plaster
- 24) Chimney breast
- (25) Window pointing
- 26) Window sills
- (27) Rendering
- (28) Brickwork / pointing
- (29) Bay window projection
- (30) Lintels
- (31) Cavity walls / wall ties
- 32) Subfloor ventilator
- (33) Damp proof course
- 34) Base course
- 35) Foundations
- 36) Solum
- 37) Floor joists
- 38) Floorboards
- 9) Water tank
- 40) Hot water tank
