YOUR ONESURVEY
HOME REPORT

4 Durness Avenue
Bearsden, Glasgow
G61 2AQ

SINGLE SURVEY

Single Survey

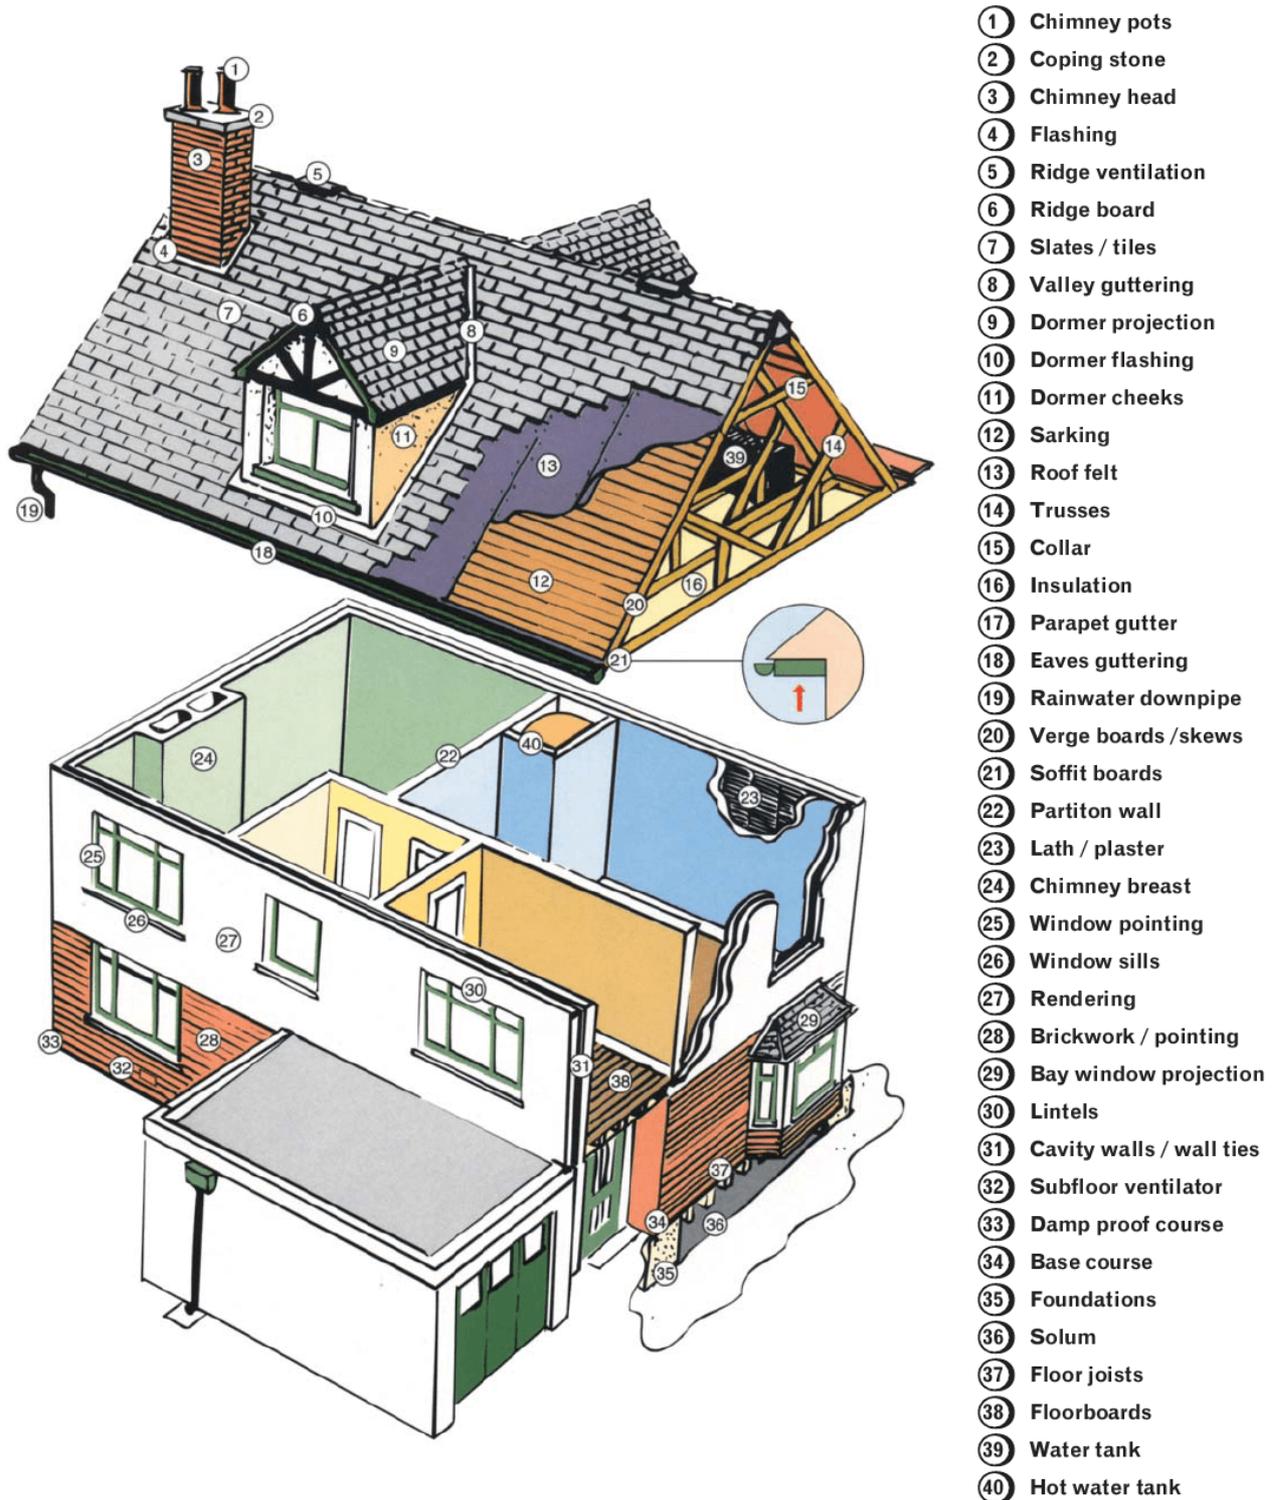
Sectional Diagram showing elements of a typical house

- ① Chimney pots
- ② Coping stone
- ③ Chimney head
- ④ Flashing
- ⑤ Ridge ventilation
- ⑥ Ridge board
- ⑦ Slates / tiles
- ⑧ Valley guttering
- ⑨ Dormer projection
- ⑩ Dormer flashing
- ⑪ Dormer cheeks
- ⑫ Sarking
- ⑬ Roof felt
- ⑭ Trusses
- ⑮ Collar
- ⑯ Insulation
- ⑰ Parapet gutter
- ⑱ Eaves guttering
- ⑲ Rainwater downpipe
- ⑳ Verge boards /skews
- ㉑ Soffit boards
- ㉒ Partiton wall
- ㉓ Lath / plaster
- ㉔ Chimney breast
- ㉕ Window pointing
- ㉖ Window sills
- ㉗ Rendering
- ㉘ Brickwork / pointing
- ㉙ Bay window projection
- ㉚ Lintels
- ㉛ Cavity walls / wall ties
- ㉜ Subfloor ventilator
- ㉝ Damp proof course
- ㉞ Base course
- ㉟ Foundations
- ㊱ Solum
- ㊲ Floor joists
- ㊳ Floorboards
- ㊴ Water tank
- ㊵ Hot water tank

Reference may be made in this report to some or all of the above component parts of the property. This diagram may assist you in locating and understanding these items.
