YOUR ONESURVEY  
**HOME REPORT**

28 Myrtle Park  
Glasgow  
G42 8UQ

# SINGLE SURVEY

A report on the condition of the property, with categories  
being rated from 1 to 3.

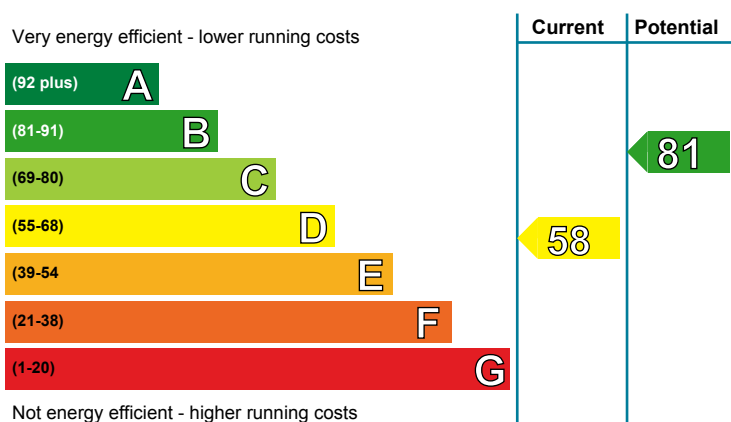
## Energy Efficiency Rating

This graph shows the current efficiency of your home, taking into account both energy efficiency and fuel costs. The higher this rating, the lower your fuel bills are likely to be.

Your current rating is **band D (58)**. The average rating for EPCs in Scotland is **band D (61)**.

The potential rating shows the effect of undertaking all of the improvement measures listed within your recommendations report.

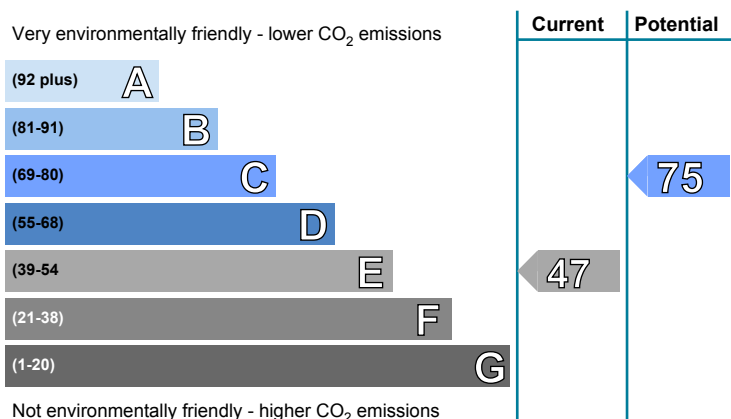
## Environmental Impact (CO<sub>2</sub>) Rating

This graph shows the effect of your home on the environment in terms of carbon dioxide (CO<sub>2</sub>) emissions. The higher the rating, the less impact it has on the environment.
