YOUR ONESURVEY  
**HOME REPORT**

Flat 2/2  
2 Ruskin Place  
Glasgow  
G12 8DZ

# SINGLE SURVEY

A report on the condition of the property, with categories being rated from 1 to 3.

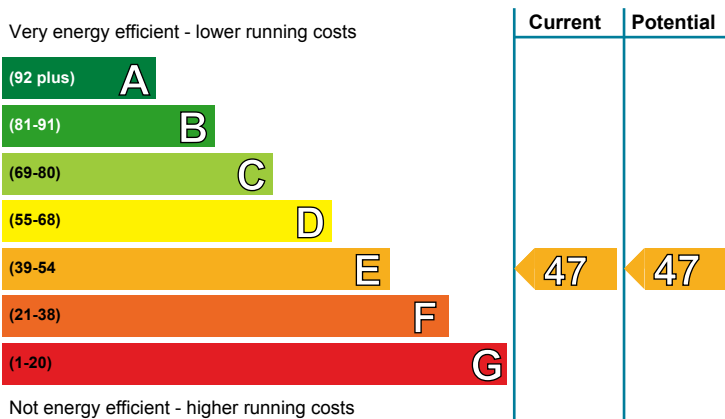
## Energy Efficiency Rating

This graph shows the current efficiency of your home, taking into account both energy efficiency and fuel costs. The higher this rating, the lower your fuel bills are likely to be.

Your current rating is **band E (47)**. The average rating for EPCs in Scotland is **band D (61)**.

The potential rating shows the effect of undertaking all of the improvement measures listed within your recommendations report.

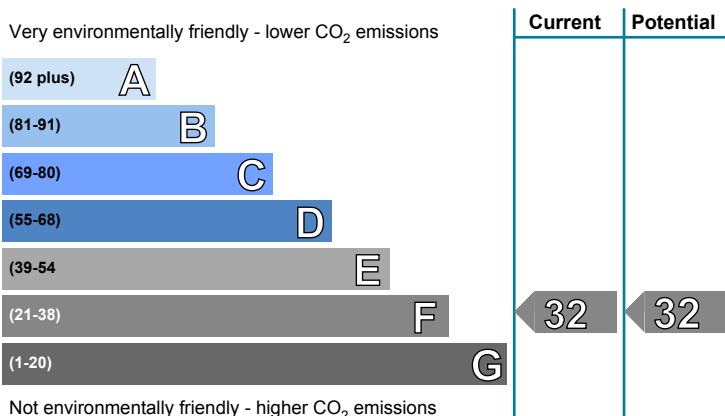
## Environmental Impact (CO<sub>2</sub>) Rating

This graph shows the effect of your home on the environment in terms of carbon dioxide (CO<sub>2</sub>) emissions. The higher the rating, the less impact it has on the environment.
